# SERVICE INFORMATION LETTER

SIL # 170508-11-6557-7WD

**SUBJECT:** It has been determined that some Wencor PMA PN 11-6557-7( )WD Bezel Assemblies shipped prior to February 27, 2017 may be defective. In particular the Lens may pop out during assembly or when impacted with a force less than 10 lbs.

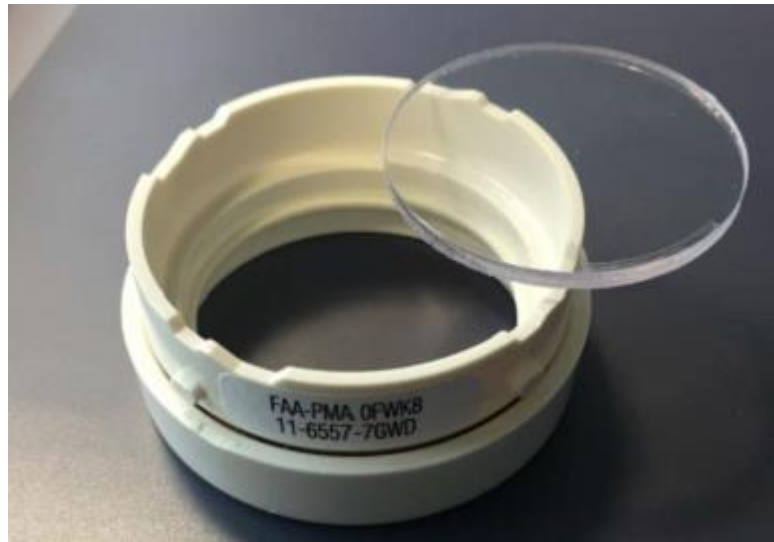
One customer has reported that the Lens on Wencor PMA PN 11-6557-7( )WD Bezels have separated from the assembly during the installation on the aircraft. After investigating it has been determined that some PMA PN 11-6557-7( )WD Bezels do not meet drawing requirements regarding workmanship with respect to adhesive application and Lens retention.

Lens detachment has been reported by one customer and was detected during installation. There have been no reports of this defect occurring after installation

Figure 1. Defective Part from Customer – Lens Separated During Installation

Any Wencor PN 11-6557-7( )WD Bezel Assemblies that are currently in service may remain in service at the discretion of the operator.

Any Wencor PN 11-6557-7( )WD Bezel Assemblies that have not been installed may be returned to Wencor for credit or replacement as described in Section 4 below.
