# SERVICE INFORMATION LETTER

SIL # 170508-11-6557-7WD

**SUBJECT:** It has been determined that some Wencor PMA PN 11-6557-7( )WD Bezel Assemblies shipped prior to February 27, 2017 may be defective. In particular the Lens may pop out during assembly or when impacted with a force less than 10 lbs.

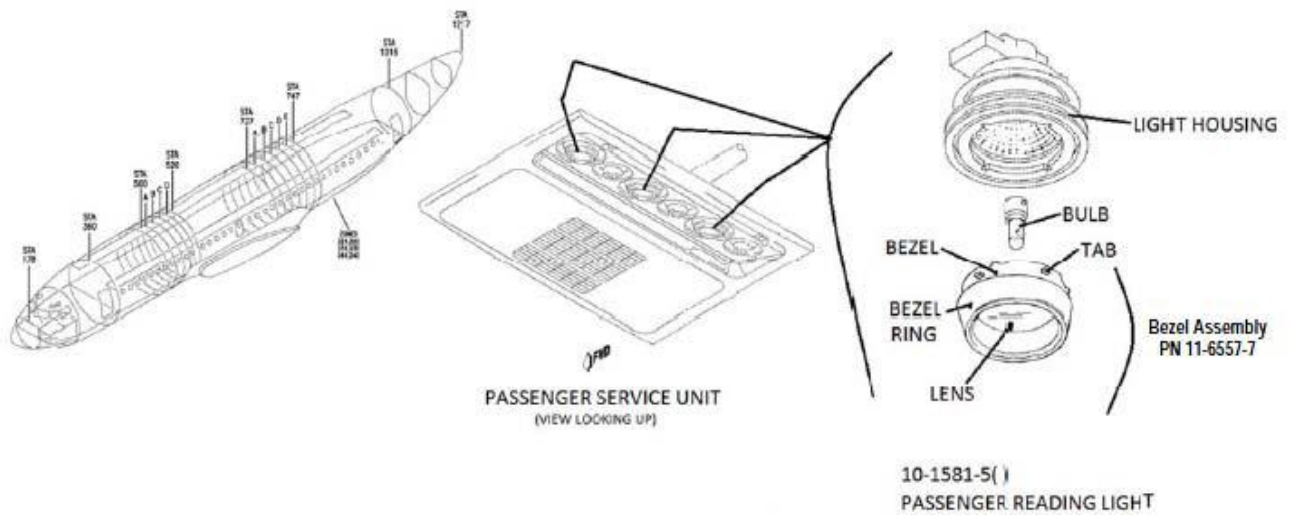
Figure 2. Typical Installation of PMA PN 11-6557-7( )WD Bezel Assembly

The subject parts are installed in the Bezel Assembly of the PSU installed on various Boeing aircraft.
